M E M O R A N D U M

DATE: June 27, 2018
TO: Scott Salsbery – City of Lawrence Utilities
FROM: Brian Payne – American Structurepoint
RE: Summary of Indian Creek Interceptor Inspection
CC: Derek Urban – American Structurepoint, Cindy Fort – American Structurepoint

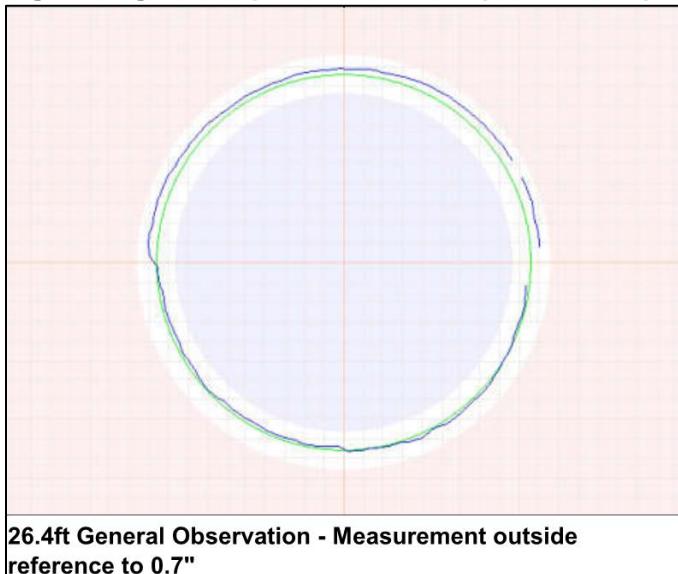
Fig 1: Original Inspection Results (24-inch I.D.)

The original inspection report from RedZone documented heavy corrosion (0.75 inches to 1.2 inches deep) occurring in some pipe segments. The amount of corrosion or deposition is calculated by

comparing the existing inside diameter of the pipe measured at the time of inspection (using laser and sonar) against a reference shape with an inside diameter equal to that of the original pipe when it was installed. Unfortunately, the inside diameter of the original pipe is not known. The as-builts drawings only indicate the pipe material and nominal pipe size, and even this information wasn't entirely accurate as it neglected to indicate the first 100 feet of the sewer was concrete pipe. The actual inside diameter varies depending on the pipe material and class of pipe. A 24-inch concrete pipe does actually have an inside diameter of 24 inches whereas modern 24-inch ductile iron pipe may have an inside diameter of 24.7 inches to 24.9 inches depending on the class of the pipe (with a wall thickness of 0.33 to 0.43 inches excluding the cementitious/asphalt liner).

The heavy corrosion originally calculated would likely have exceeded the thickness of ductile iron pipe resulting in holes in the pipe which were not observed during the inspection. The original pipe wall thickness is unknown, however with help from the Ductile Iron Pipe Research Association (DIPRA) an expected wall thickness of 0.6 inches (including a thin 1/8-inch cementitious lining) was determined for ductile iron pipe installed in 1977. After consultation with RedZone and DIPRA, it was determined that the inside diameter of the ductile iron pipe would be more accurately evaluated as 24.5 inches rather than the 24 inches used in the original inspection report. According to DIPRA, 24.5 inches would be closer to the typical inside diameter of ductile iron pipe manufactured at the time the interceptor was installed (1977).

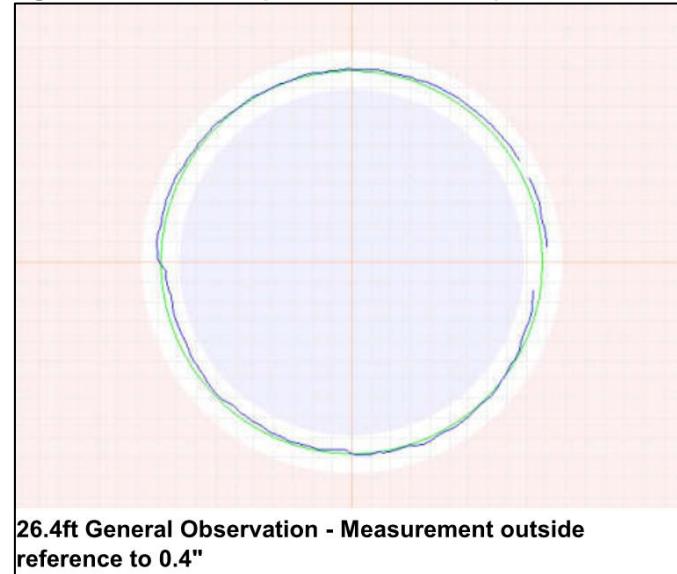
Fig. 2: Revised Inspection Results (24.5-inch I.D.)

Redzone issued a revised report on June 18th with the revised 24.5-inch reference diameter for the ductile iron pipe (the first 100 feet of concrete pipe was left at 24-inch diameter). Changing the reference diameter also reduced the overall corrosion which was more consistent with what was visually observed in the CCTV sewer inspection video. The two figures that follow show the sonar and laser inspection results (blue line) at the same sewer location before and after changing the reference shape diameter (green line). Where the blue line is inside of the green line there is deposition; where the blue line is outside of the green line there is corrosion; and where the blue and green line match the pipe is unchanged from its original dimensions at time of installation.

Before the diameter change, the reference shape generally matched very closely to the sonar profile (pipe measured below the flow line). RedZone indicated this is typical for relatively clean sewer pipe like the Indian Creek Interceptor. Generally, following the diameter change the shape of the invert and

crown of the inspected pipe still match the reference pipe diameter well, but closer to the spring lines of the pipe deposition was now measured near and below the flow line and corrosion above the flow line. There is actually some grease buildup visible in some of the sewer segments near the spring line, which is consistent with this measurement.

Overall, the change of the reference shape to 24.5-inch diameter for Ductile Iron Pipe produced more accurate, realistic results that better fit what was visually observed during inspection. RedZone revised their report based on the new reference shape. The revised inspection report is included with this memo and was used as the basis of this memo.
